FISCAL YEAR 2017 ANNUAL PERFORMANCE REPORT NEW BRIGHTON/ARDEN HILLS SUPERFUND SITE

**July 2018
Final Report**

FISCAL YEAR 2017 ANNUAL PERFORMANCE REPORT

New Brighton/Arden Hills Superfund Site

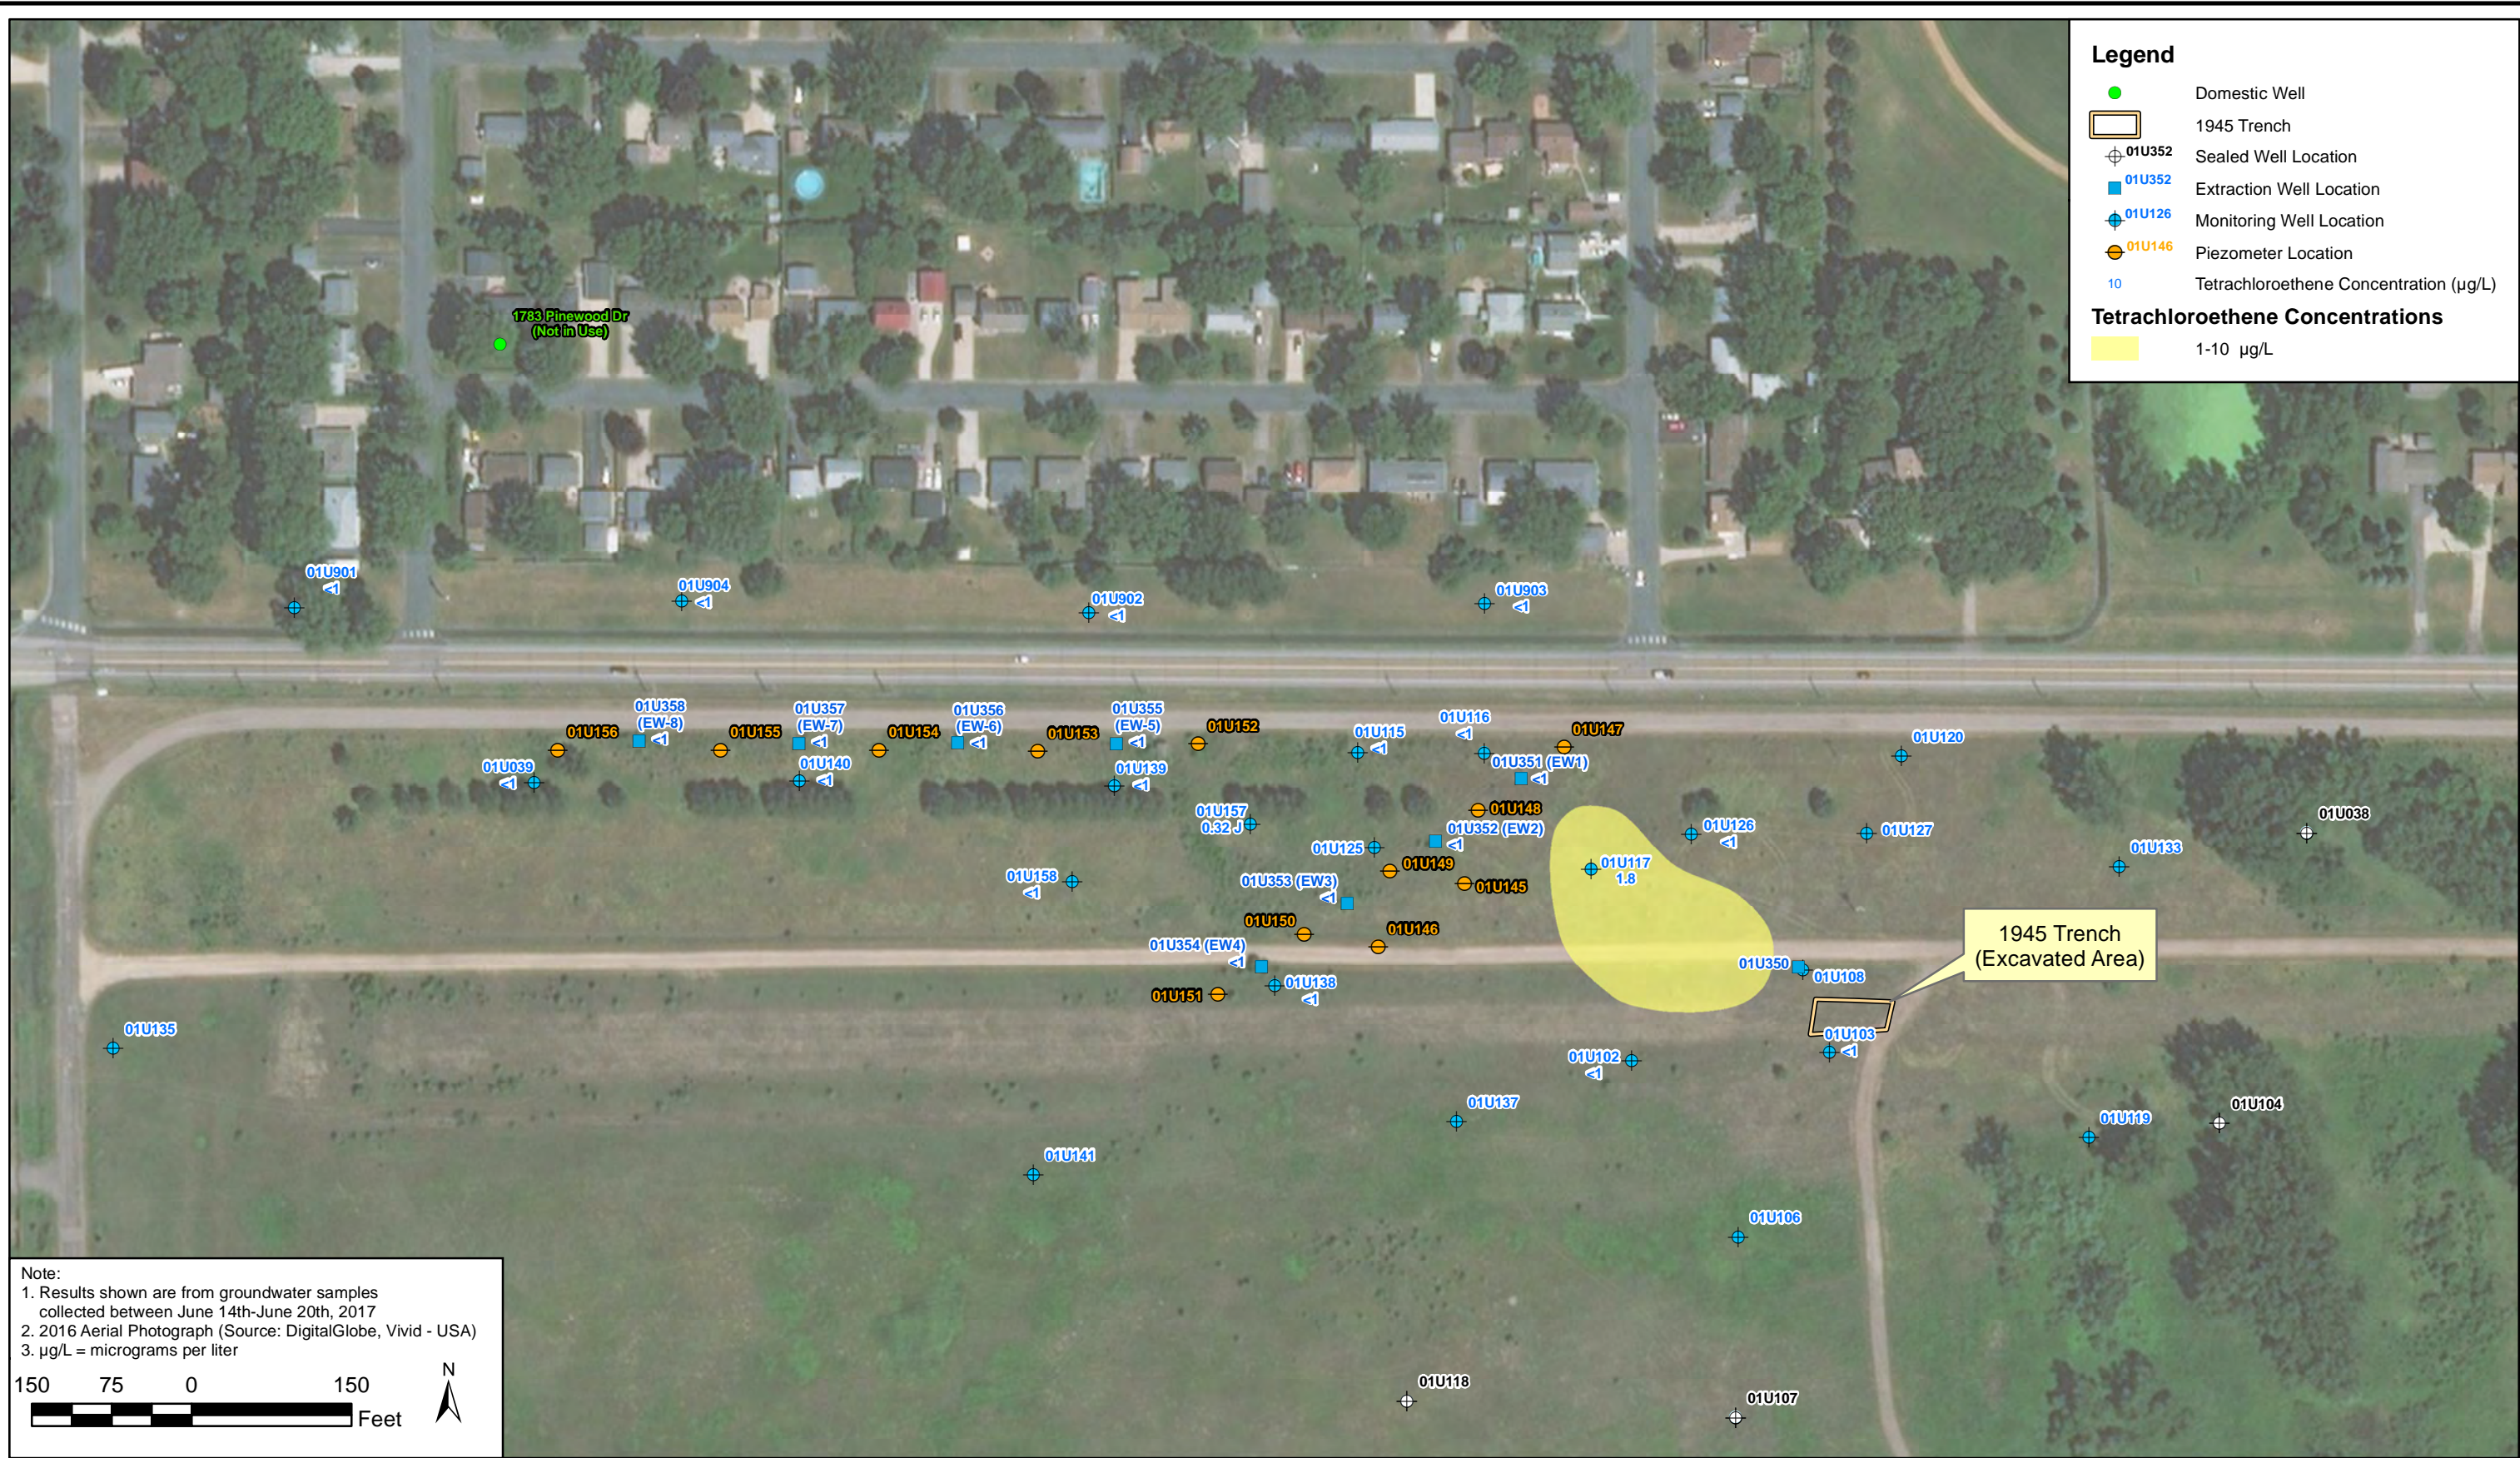
Figure 6-3

No. **Table 6-2** presents the FY 2017 groundwater quality data for Site A. Using these data, **Figure 6-3** shows the tetrachloroethene (PCE) concentrations and **Figure 6-4** shows the cis-1,2-dichloroethene (cis-1,2-DCE) concentrations. The latter is a degradation product of the former and represents the larger areal footprint. The plume did not increase in size, but it appears to have migrated slightly downgradient from the previous year, as shown on **Figure 6-5**.

As evident in [Table 6-2](#), and on [Figures 6-3 and 6-4](#), PCE and TCE continue to be degraded to cis-1,2-DCE via natural attenuation. This degradation generally occurs within the distance between the source area and the first line of extraction wells (EW-1 through EW-4), with primarily only cis-1,2-DCE being detected downgradient of the first line of extraction wells. [Figure 6-6](#) shows the cis-1,2-DCE concentrations plotted on geologic cross sections to illustrate the vertical extent of contamination (the cross-section locations are illustrated on [Figure 6-4](#)). Cis-1,2-DCE continues to be degraded via an abiotic process as the plume migrates. The MPCA and USEPA initially evaluated attenuation at the site using computer modeling of contaminant degradation, as documented in Evaluation of Natural Attenuation of Chlorinated Solvents in Ground Water at the Twin Cities Army Ammunition Plant (MPCA

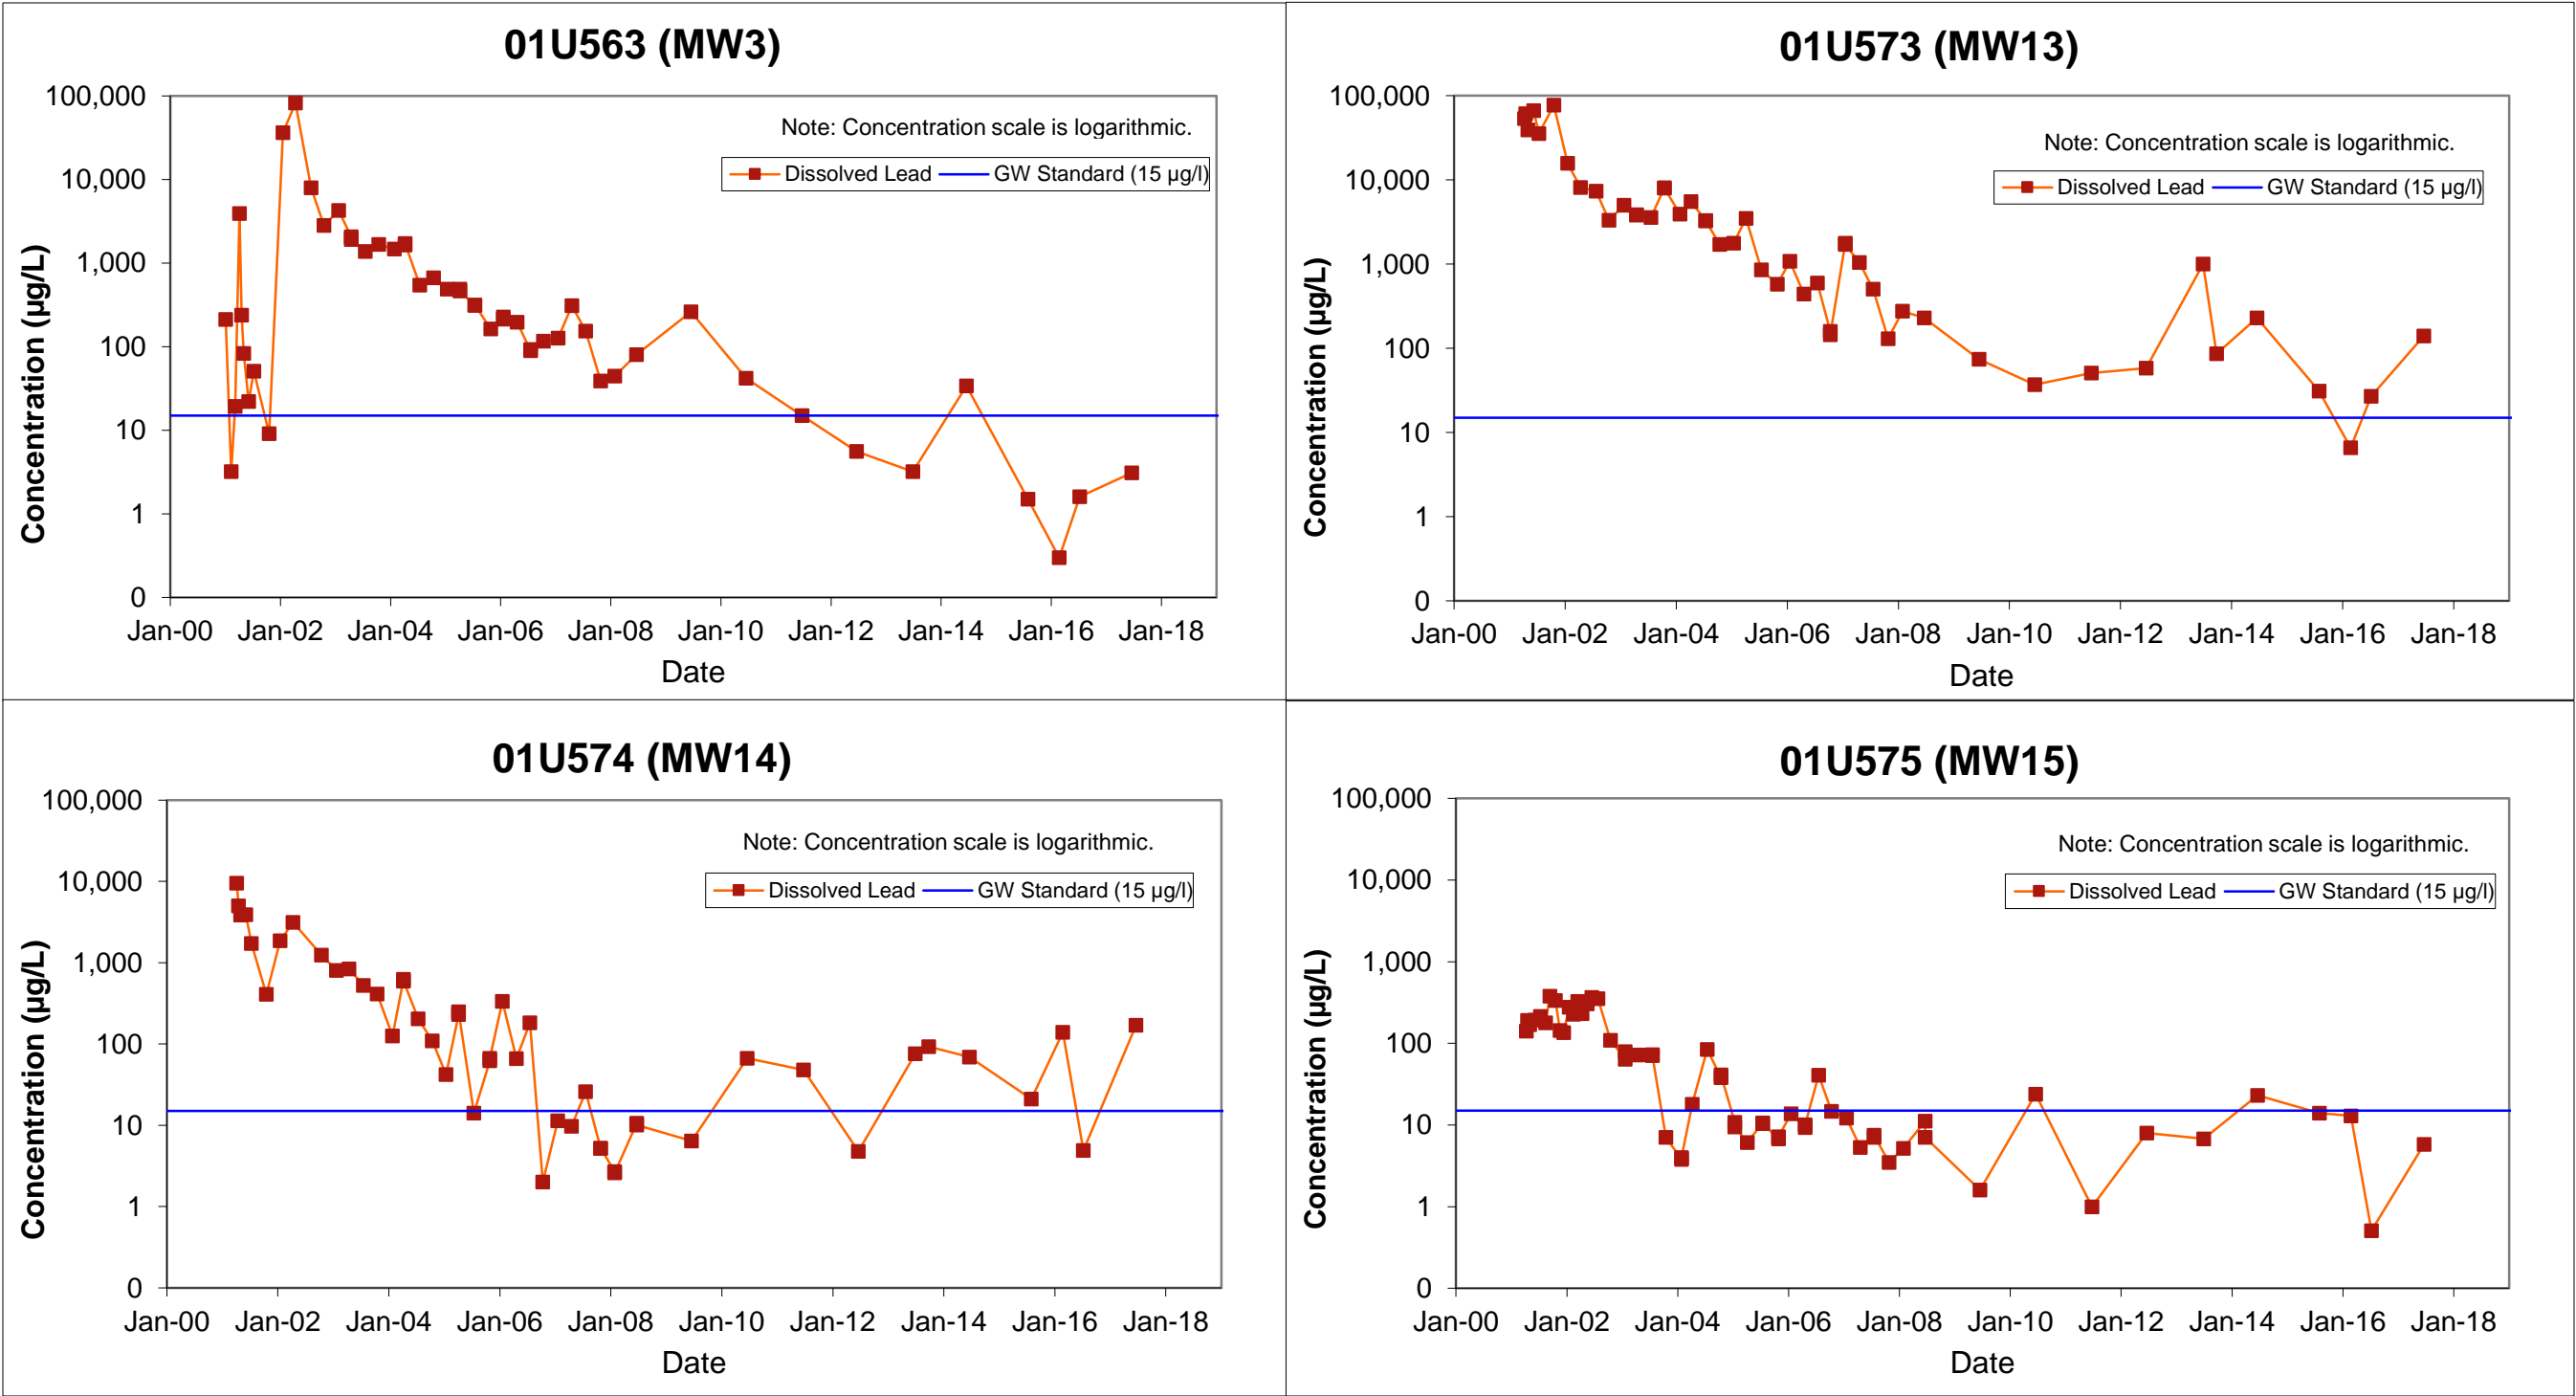
Figure 7-6
Dissolved Lead

In FY 2017, lead exceeded the groundwater cleanup level of 15 µg/L in two monitoring wells located near the source area. The lead concentrations at MW-13 and MW-14 were detected at 140 µg/L and 170 µg/L in June 2017. The water quality trends (dissolved lead) for wells nearest the source (MW-3, MW-13, MW-14, and MW-15) are shown on Figure 7-6. As Figure 7-6 shows, the variable concentrations observed at individual wells in FY 2017 has occurred throughout recent years for the four source area wells. Overall, lead concentrations at source area wells have decreased significantly in the last 10 years indicating substantial progress towards reaching groundwater cleanup levels. Surface water monitoring locations were not sampled in FY 2017 but will be completed in FY 2018.
